# Little Crow

### TRANSPORT STATEMENT

A Planning Application by  
**INRG SOLAR (LITTLE CROW) LTD**

## **Transport Statement**

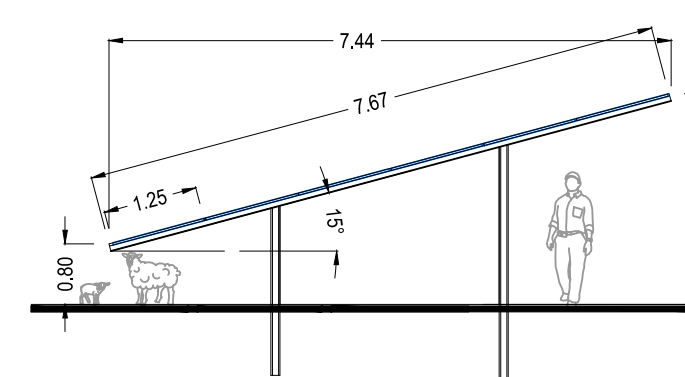
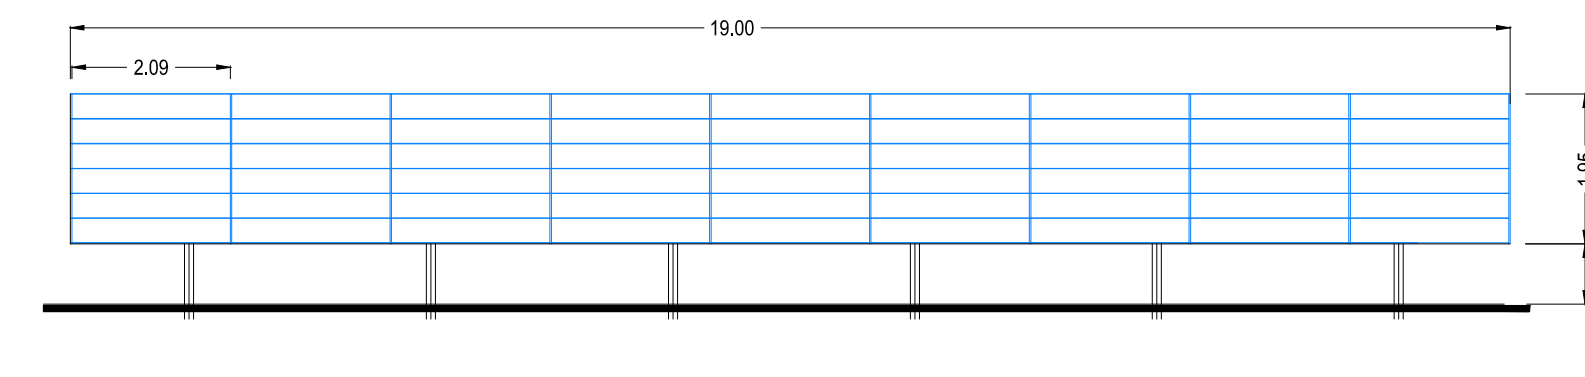
Section Scale  
1:100

Array 6L x 9; 15°

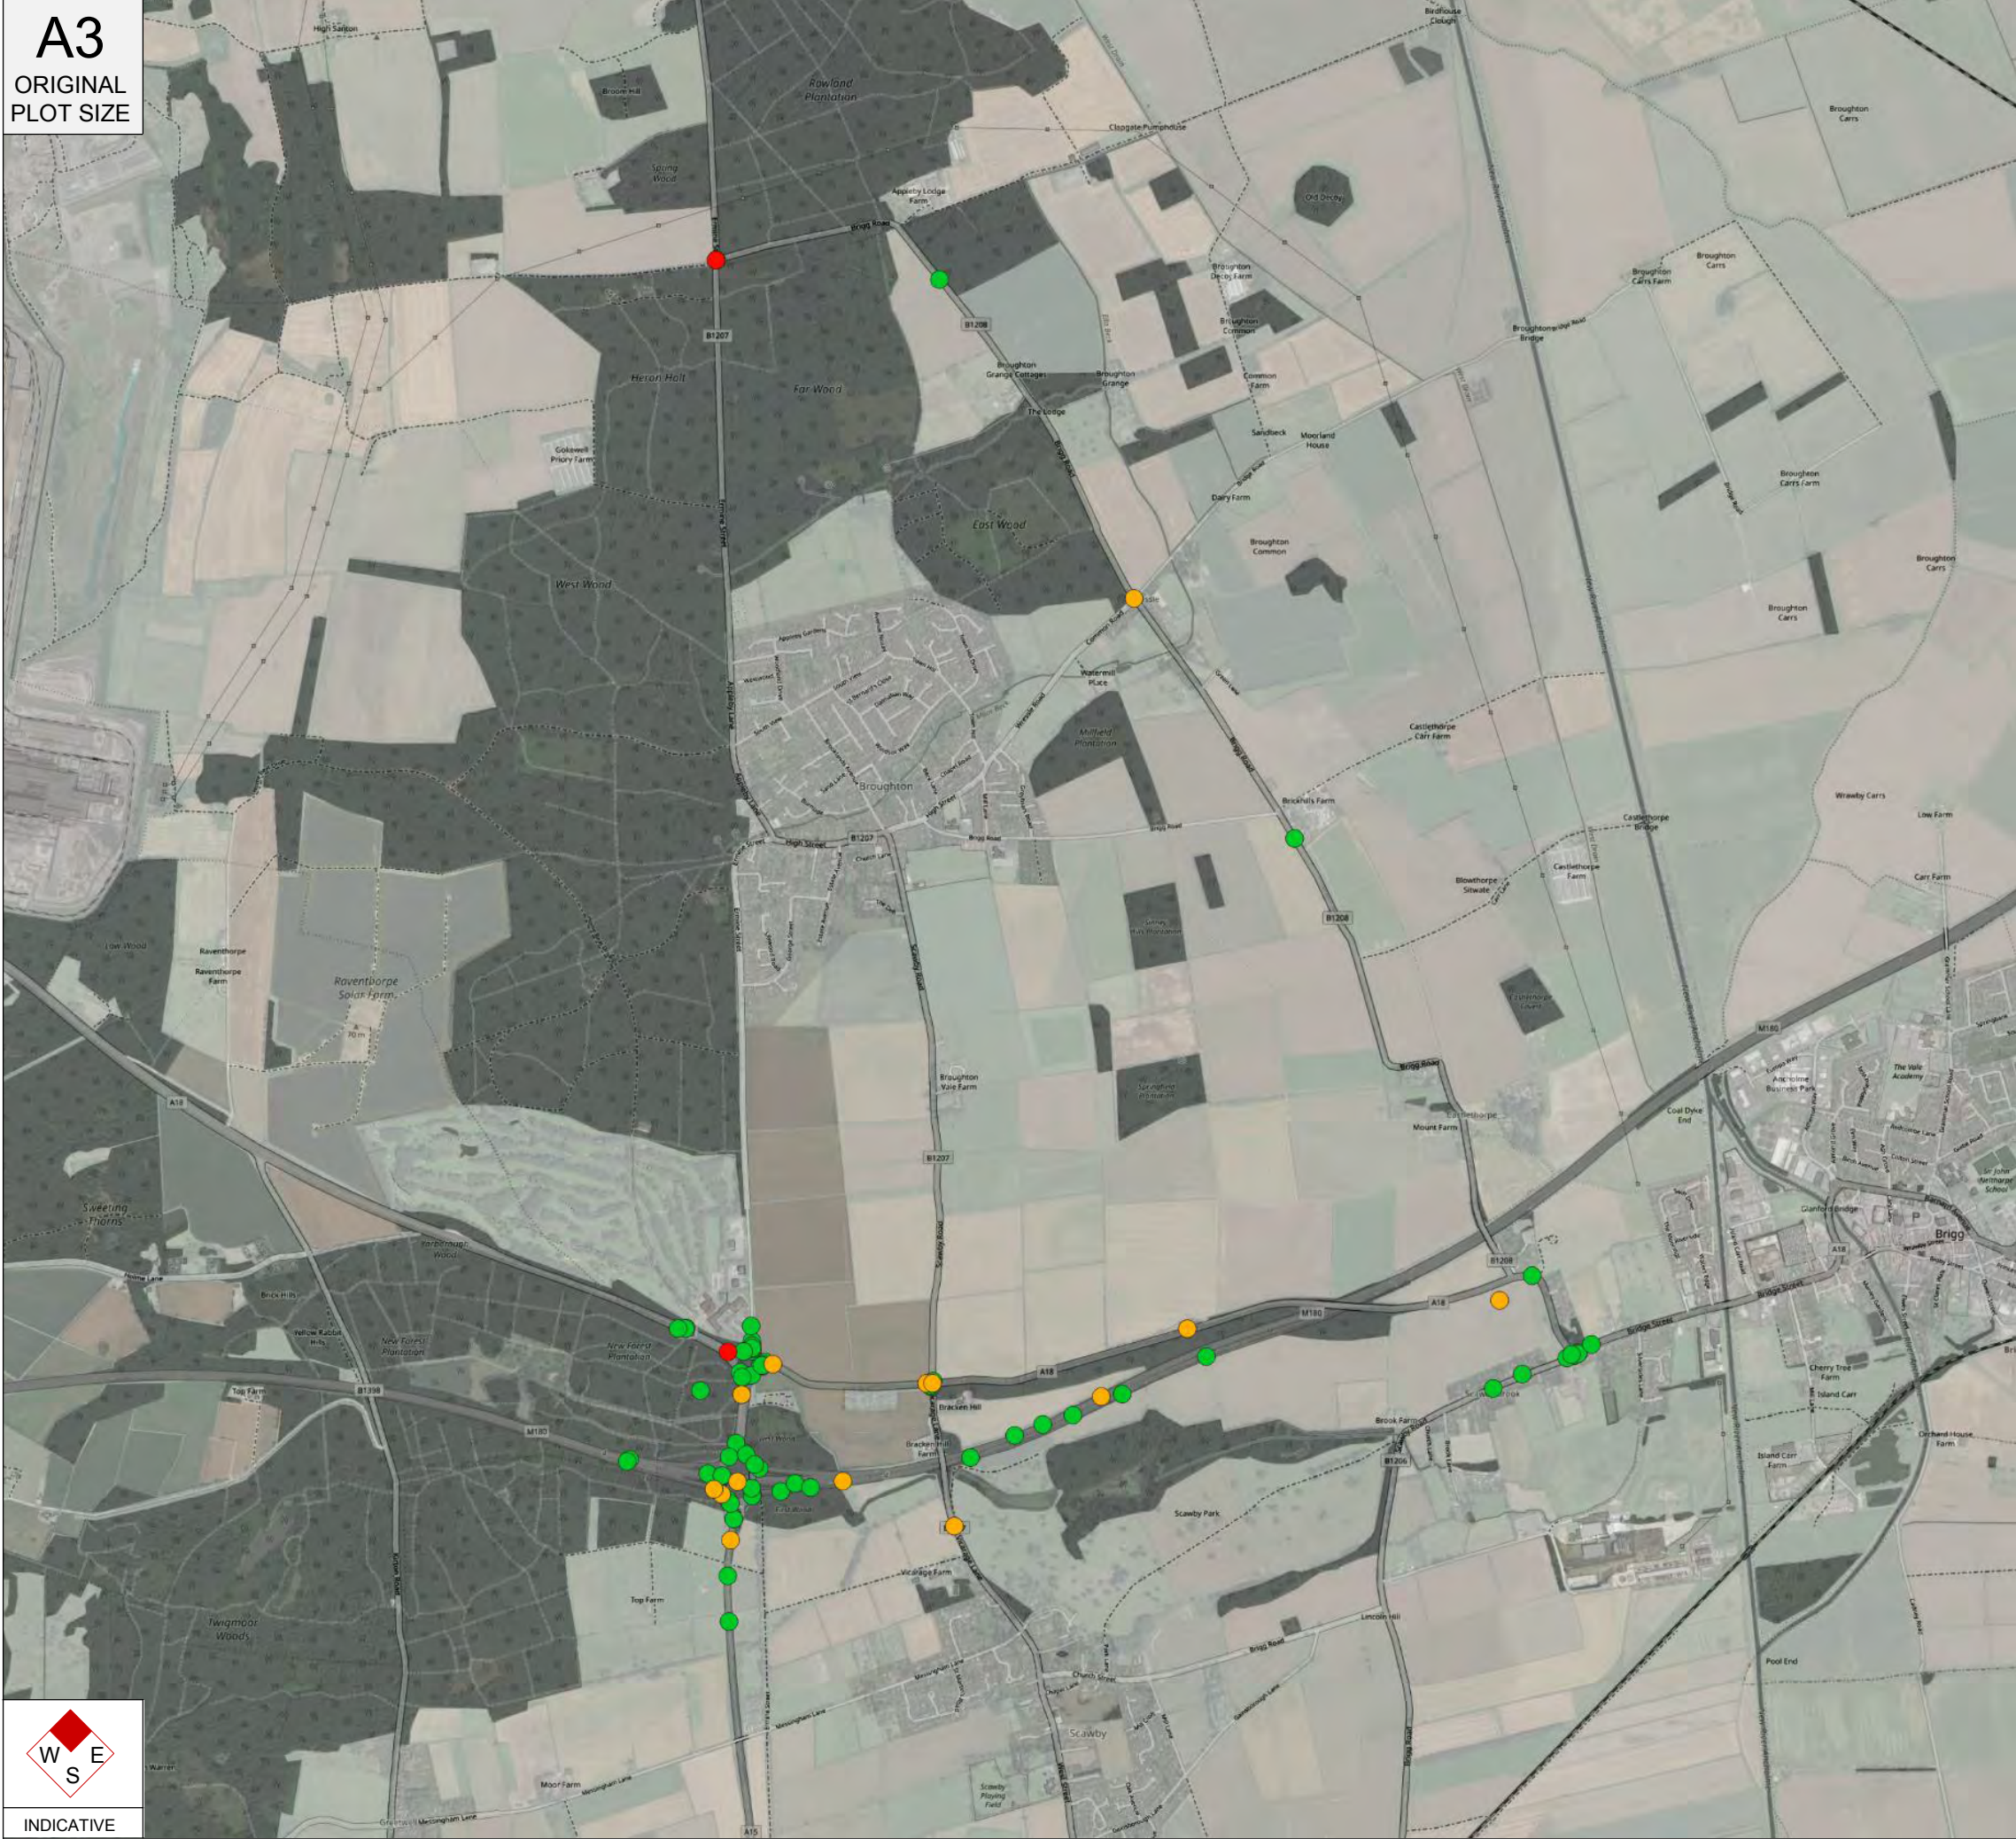
- NOTES:
- Fatal
  - Serious
  - Slight

- 1.5 The accident data report is provided at **Appendix A**.
