# Little Crow

*Little Crow Solar Park, Scunthorpe*

### TRANSPORT STATEMENT

## **Transport Statement**

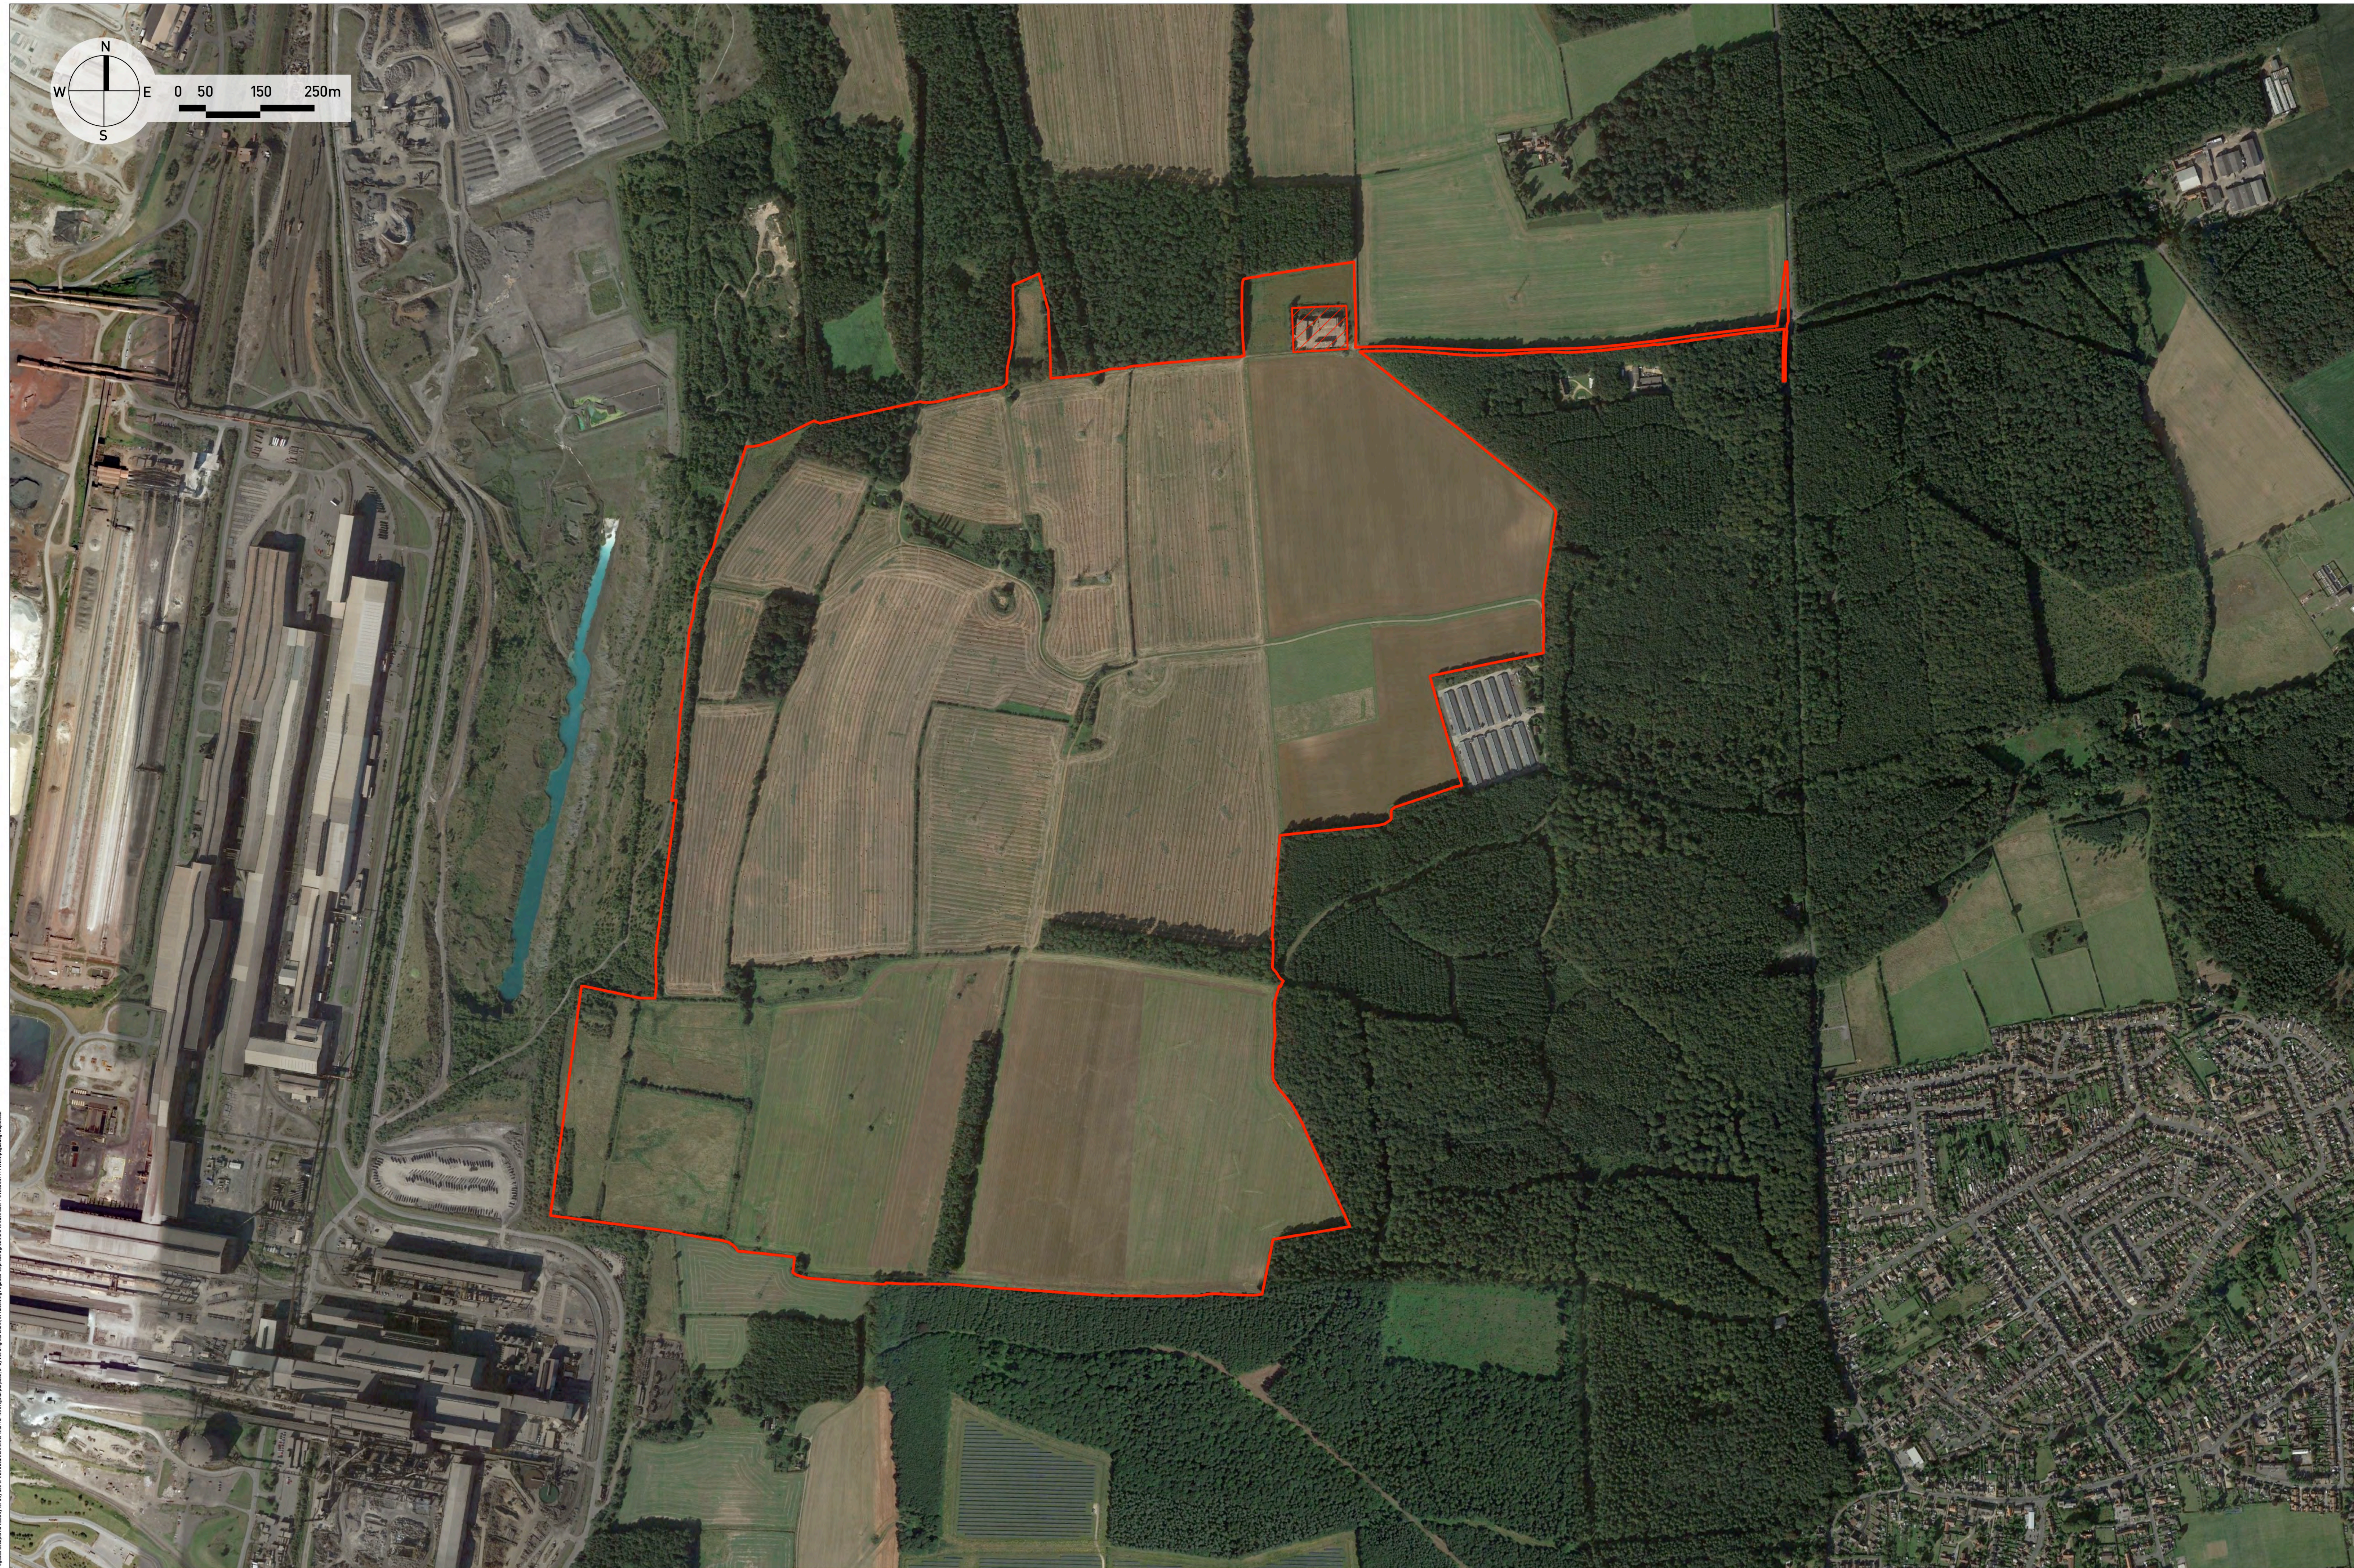
**DOCUMENT REFERENCE NUMBER: 2.39 LC DRW**

LITTLE CROW SOLAR PARK - INDICATIVE AERIAL IMAGE OF ORDER LIMITS

- 1.2 An aerial plan showing the Order Limits (Document Ref 2.38 LC DRW) is included in **Appendix A**. The area comprises approximately 225 hectares of land located approximately 2.1 kilometres north of the village of Broughton. Junction 4 of the M180 is approximately 4.5 kilometres to the south.

- 2.2 An aerial plan showing the Order Limits (Document Ref 2.38 LC DRW) is shown in **Appendix A**.
- 2.3 The Order Limits comprises approximately 225 hectares of land located approximately 2.1 kilometres north of the village of Broughton. Junction 4 of the M180 is approximately 4.5 kilometres to the south.

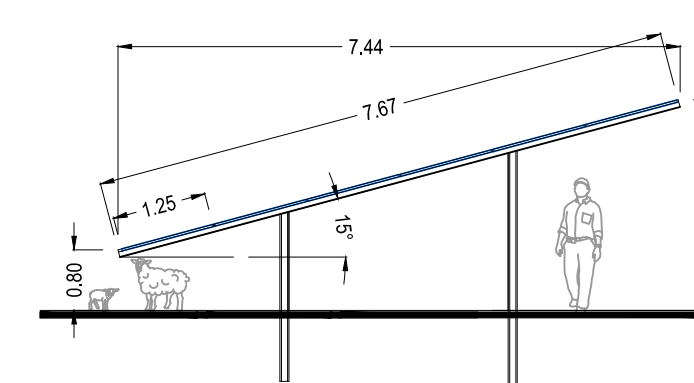
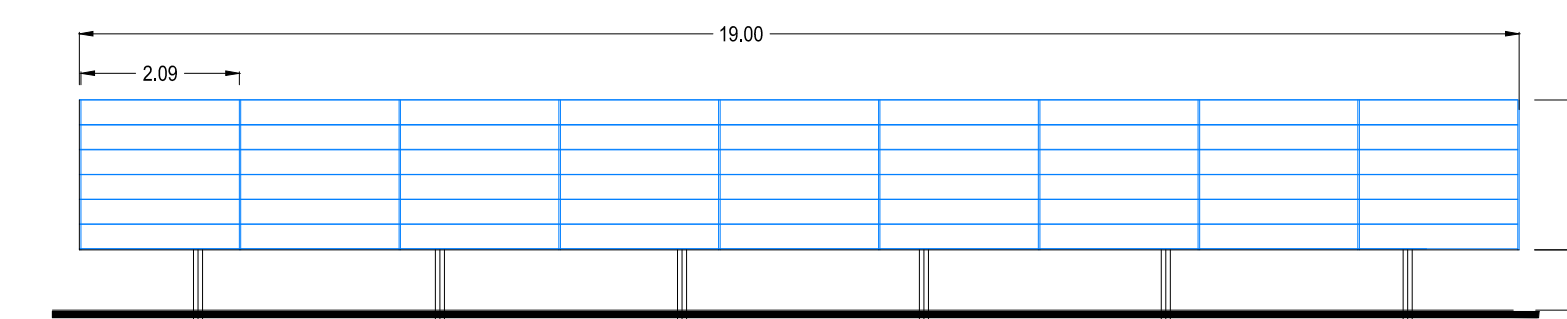
Section Scale  
1:100

Array 6L x 9; 15°
